# Property Inspection Report

111 Dream House Lane  
Any, II 11111

Inspection Number: 00000

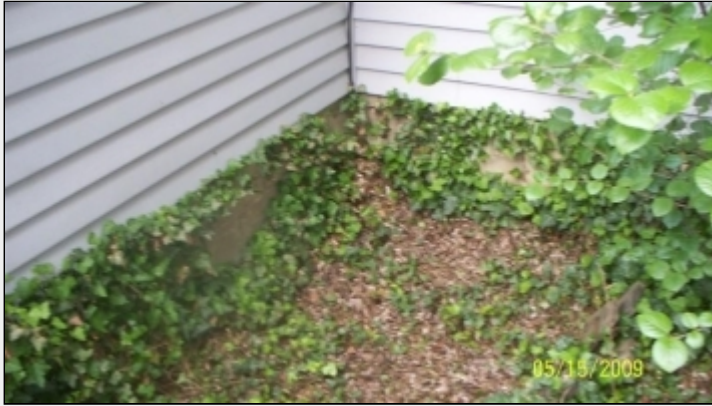
### **Section: I. Grounds » Item: F. Property Drainage**

**C-1:** Slope is toward the home; recommend adding fill.

The slope is incorrect on the west side; recommend adding fill to improve the grade.

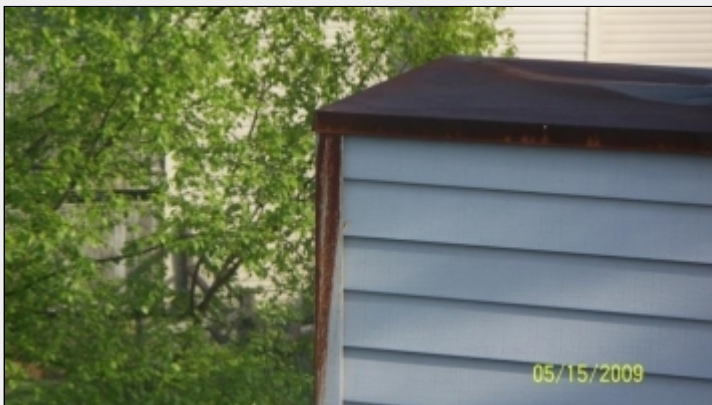
### **Section: III. Roof » Item: B. Chimney**

**C-4:** Chimney cap is in need of attention.

Chimney cap is rusted; recommend re-painting.

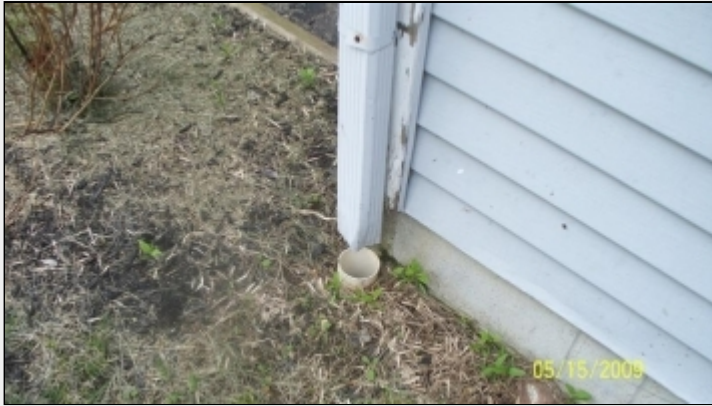
**Section: III. Roof » Item: C. Downspouts/Extensions**

**C-5:** Downspouts are not aligned with drains; recommend adjustment

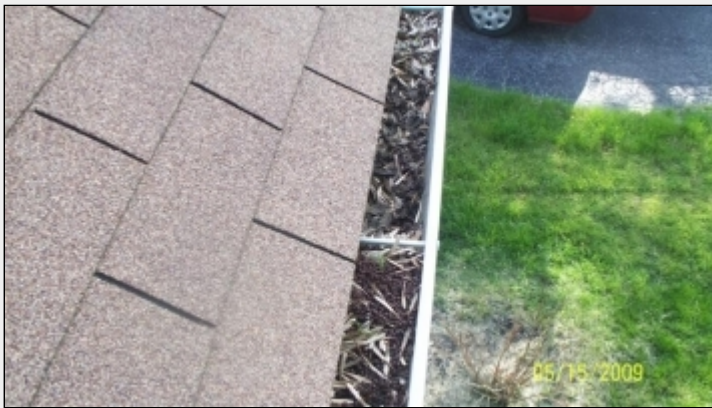
**Section: III. Roof » Item: D. Gutters**

**C-6:** Debris is building up, recommend cleaning.

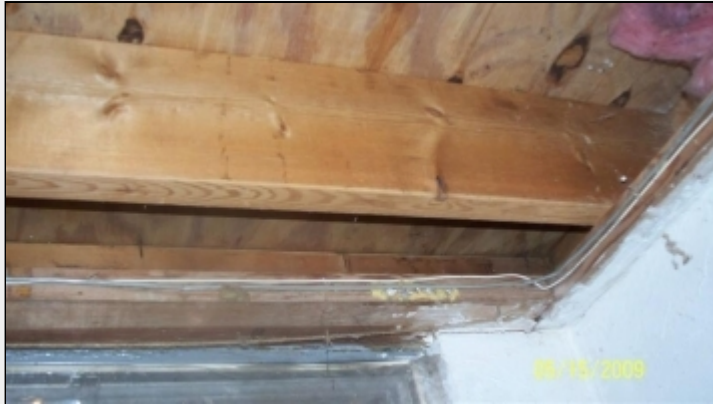
**Section: IV. Structural » Item: G. Sub Floor**

**C-8:** Carpenter ant present; recommend treatment

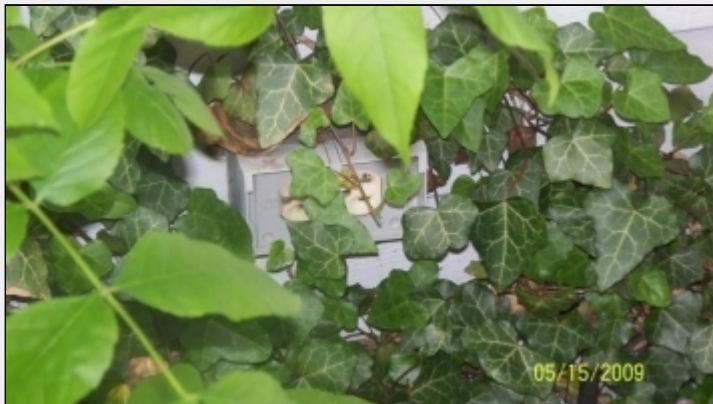
**Section: XI. Electrical - Lighting » Item: A. Exterior Recepticles**

**C-11:** Outlet cover is damaged; recommend replacement

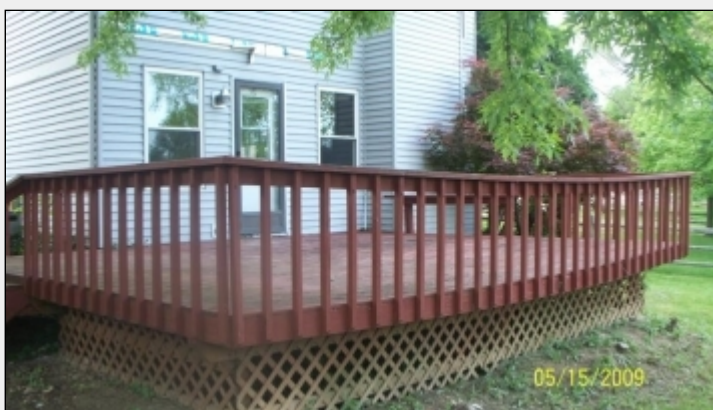
**Section: I. Grounds » Item: D. Rear Deck / Porch**

I-1: Deck is in poor condition.

The deck is sagging in the center; approx 10 inches. Recommend repairs, or rebuilding the deck by licensed OH contractor.

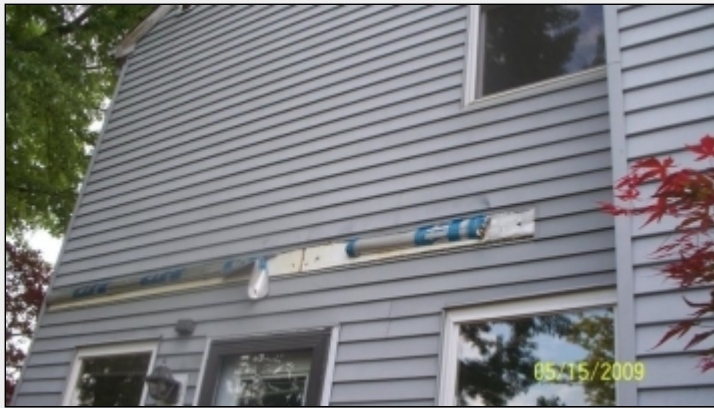
**Section: II. Exterior » Item: D. Wall Covering - South**

I-2: Siding missing

Siding is missing; recommend repair, on the south side of structure.

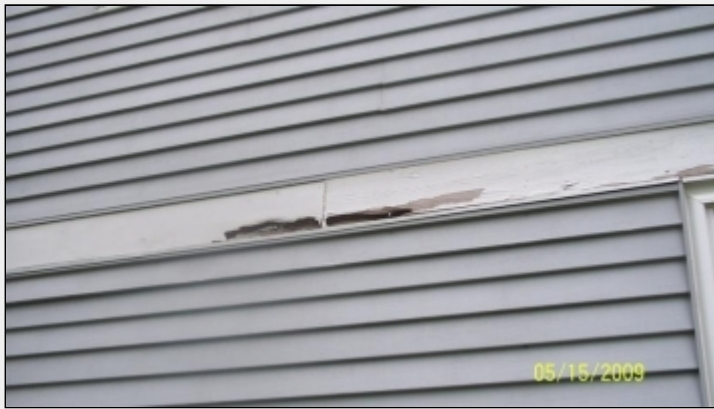
**Section: II. Exterior » Item: F. Trim**

**I-3:** Damaged present.

Trim is rotted in several areas; recommend 100% inspection & repair as needed. See below photos as well.

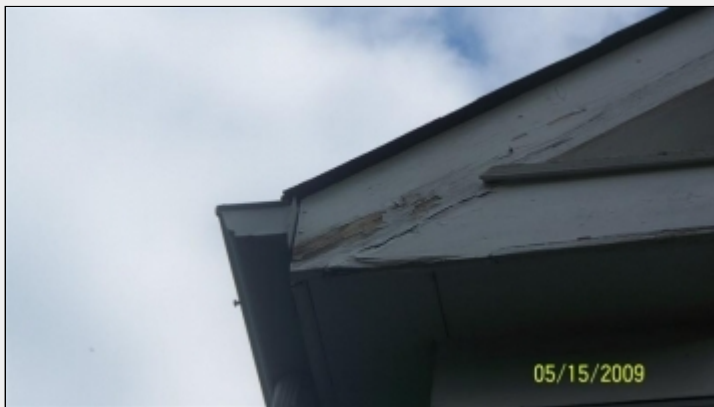
**I-4:** Wood rot is present.

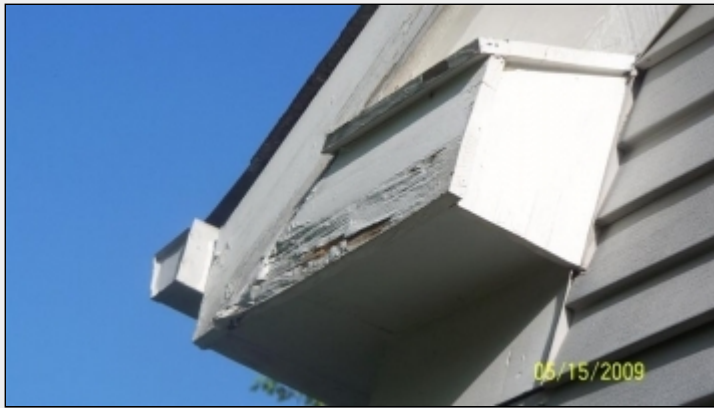
**I-5:** Wood rot is present.

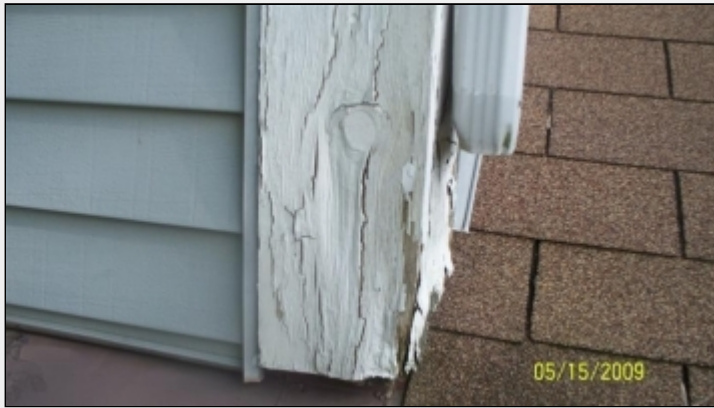
**I-6:** Wood rot is present.

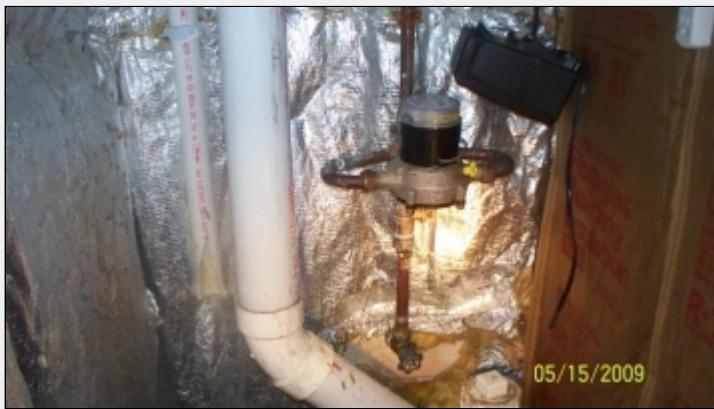
**Section: V. Plumbing » Item: A. Main Shut Off Valve**

**I-7:** Leaking at valve

Evidence of a leaking valve was visible.

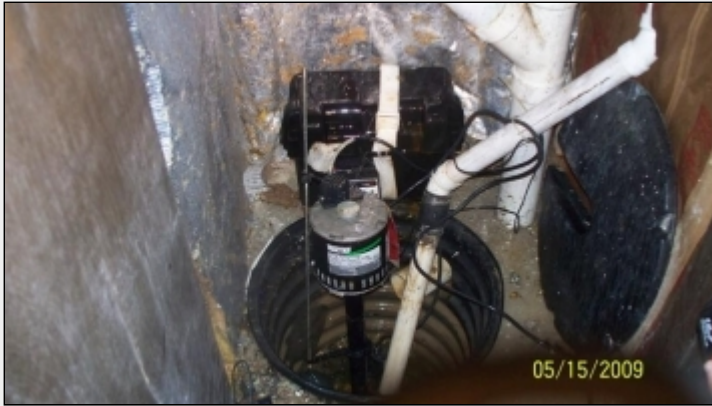
**Section: V. Plumbing » Item: B. Sump Pump**

**I-8:** Pump not operated.

Sump pump piping is damaged; recommend repair.

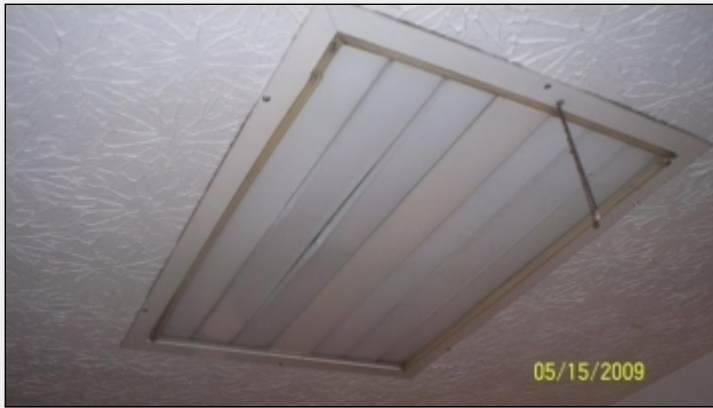
### **Section: XI. Electrical - Lighting » Item: G. Interior Fans**

**I-12:** Attic house fan did not operate.

Fan does not operate; recommend repair.

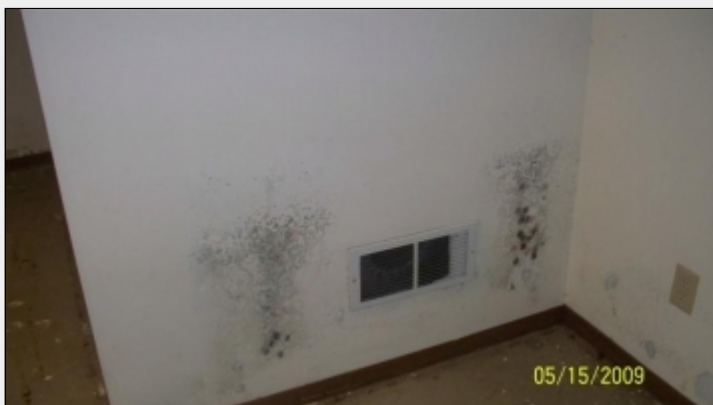
**Section: XVI. Interior - Basement » Item: G. Wall Finishes / Moisture Penetration**

**I-15:** Mold present

What appears to be mold or mildew is present, recommend testing by mold remediation company, and to remedy.

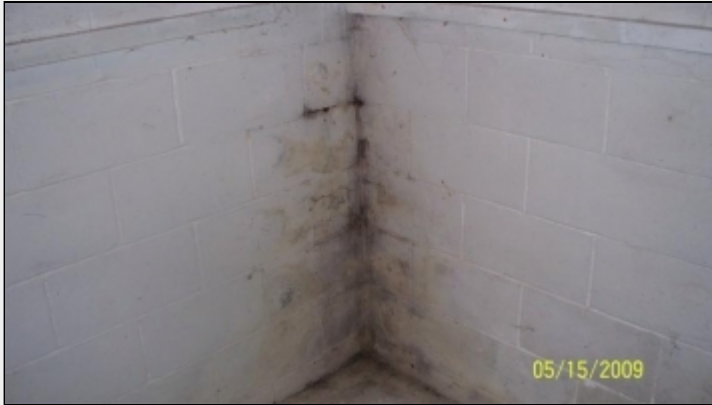
**I-16:** Mold present

What appears to be mold or mildew is present, recommend testing by mold remediation company, and to remedy.

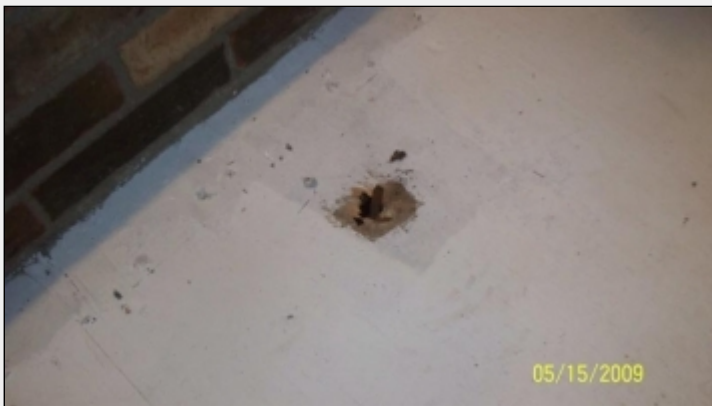
**Section: XIX. Fireplace » Item: A. Hearth**

**I-17:** Gas valve not operating.

Gas valve does not operate; recommend replacement.
